Quantum  
Blast Technologies

# CASE STUDY

# St Barbara's Simberi Gold Mine

## Enhancing Infrastructure Maintenance with RapidBlast™ Wet Abrasive Blast Equipment

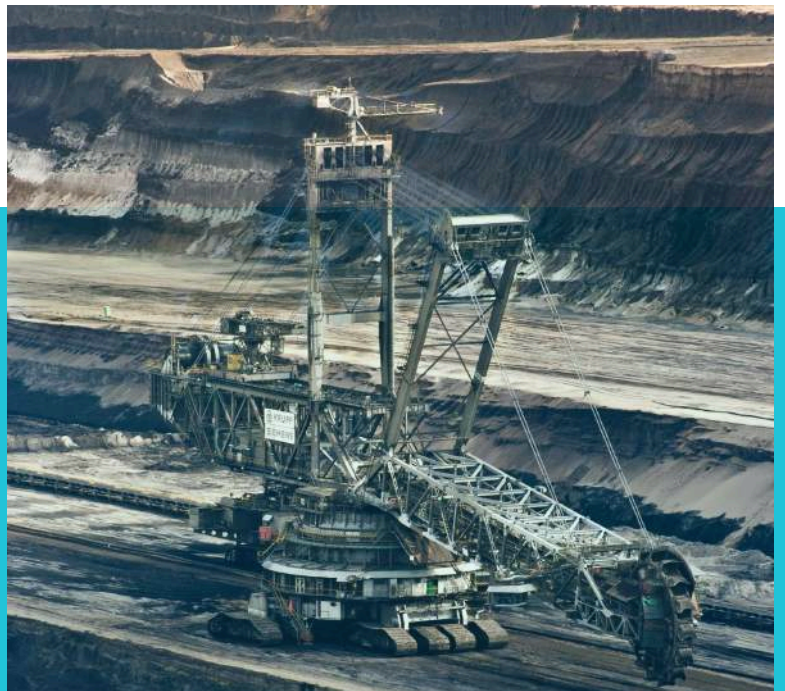
**Wet Abrasive Blasting** is particularly useful in the mining industry as it provides dust control, environmental compliance and superior surface preparation. It is suited for large equipment and rigid structures without the need for containment.

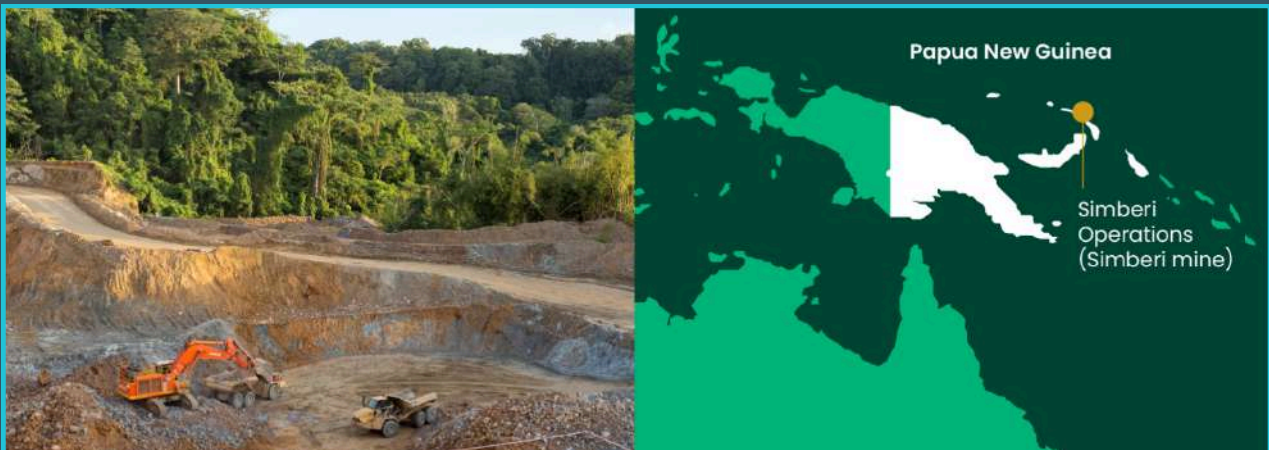
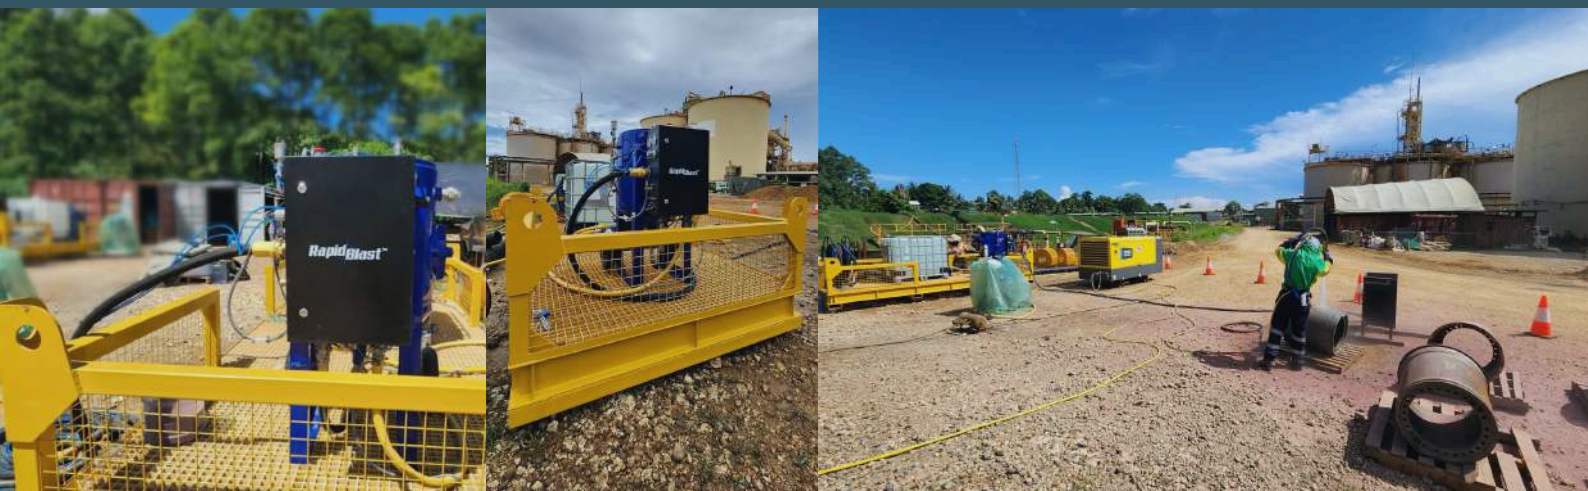
The chosen solution was the RapidBlast™ SD140 Wet Abrasive Blasting Equipment, custom-mounted on a purpose-built, hot-dip galvanized skid designed specifically for the challenging conditions of the Simberi Gold Mine.

Constructed from 8mm stainless steel and adhering to both Australian AS1210 and European CE and ATEX standards, this equipment offers robust performance in explosive environments. It features a 155 Ltr powder coated pressure vessel, designed for ergonomic handling and efficiency, even in the most extreme conditions.

The custom-built platform supports over 3 metric tons, accommodating the RapidBlast equipment, a tonne of garnet, a 1000-liter water tank (IBC), a hose reel, and a water filter system. The skid's bright yellow paint enhances visibility and safety, crucial in the mine's operating environment.

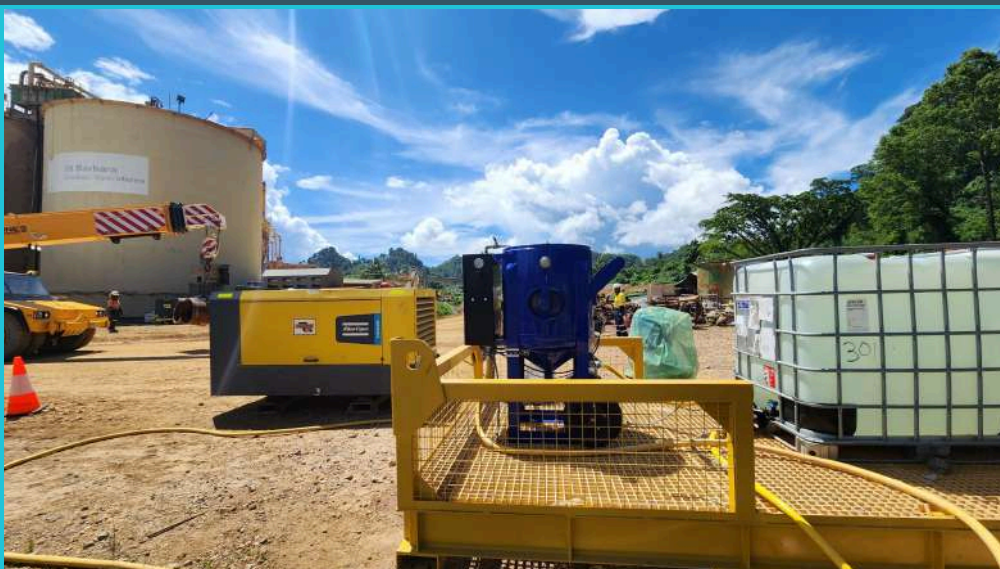
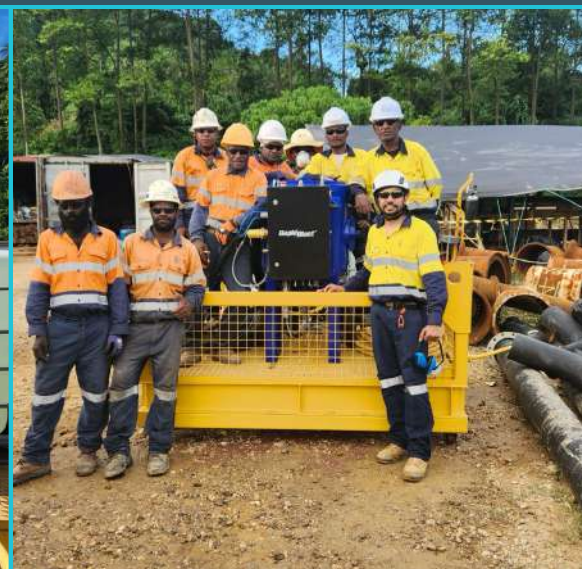
The implementation of the RapidBlast™ SD140 has revolutionized maintenance processes at Simberi Gold Mine by,

- **Significantly Reducing Environmental Impact:** The wet blasting method captures up to 95% of dust particles, dramatically reducing airborne contaminants and aligning with the mine's environmental goals.
- **Enhancing Surface Preparation Quality:** The ability to achieve a consistent SA2.5 cleanliness standard across different materials ensures the longevity of the applied protective coatings, reducing the frequency and cost of future maintenance.
- **Improving Safety and Operational Efficiency:** The ergonomic design and easy operability of the equipment, combined with enhanced safety features, minimize operator fatigue and risk.
